**0018** **Technical Service Information****Subject:** Integrated rotary shaft seals**Relates to:** 81-90006-00
81-90010-00
81-90016-00
81-90018-00**Make:** Volkswagen, Audi, Seat, Skoda**Model(s):** Various**Engine code:** Various**Integrated rotary shaft seal -
installation information**

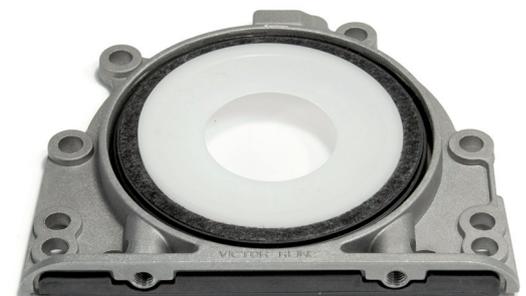
The rubber coating underneath the integrated rotary shaft seals has no sealing function [Fig. 2]. For this reason, the application of additional sealing compound or a corresponding oil sump gasket is necessary during replacement.

Figure 2_Underside of the integrated rotary shaft seal

This means that the oil sump always needs to be detached and newly re-sealed whenever the integrated rotary shaft seals are replaced.
